6: District Facilities Assessment

Site Recommendations for Mann Middle School

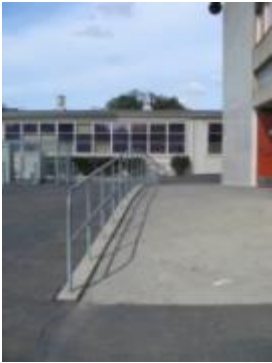
Entrance to Bldg. 04-15

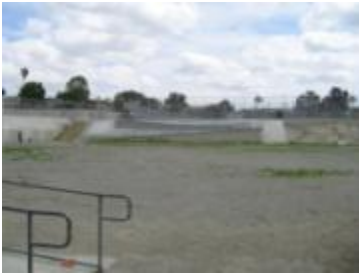
Play Field and Access to Additional Play Surface

- Entrances and exits to the site and locations of fields should also be evaluated and modified to provide adequate parking and playfields that meet standards

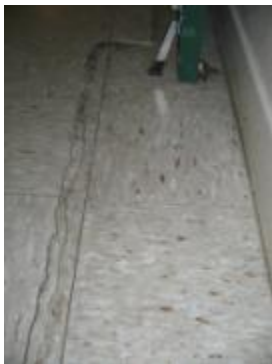
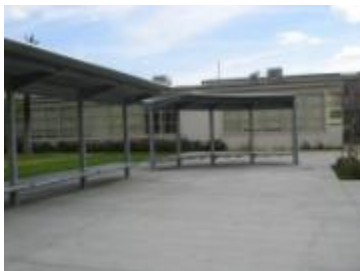
- Current academic structure is divided into Small Learning Communities
- The school site is not overcrowded
- Enrollment is declining and currently at about 50% ca
- Building 01-03/02-08 is over 50 years old and in need of structural repairs
- Many of the buildings on campus need extensive modifications for ADAG compliant access
- There are new roofs on all buildings
- Relos still remain on site from Prop MM swing space
- Site's hard surface is in poor condition

- Evaluate the site with the relationship to the Jackson Elementary School site to determine if the two school campuses should be combined since both schools have reduced enrollment projections; This campus could be a candidate for a new K-8 configuration or have two separate schools functioning on one campus. New site layout should provide safer access to both schools

- The majority of buildings should be replaced due to costs of repair & upgrades of the existing buildings
- A combined campus plan should evaluate if any existing buildings should remain on site or if their location hinders the best layout for the campus
